**Flood Control Project Maintenance  
Levee Inspections**

**Fall 2014 Levee Maintenance Deficiency Summary Report**

**Sutter Maintenance Yard Maintenance Area 0017**

Waterway			Bank	Unit Miles
Unit No. 01 Lake County Sutter Maintenance Yard - Middle Creek			Left	3.87
	Spring (March - May)	Summer (June - August)	(September - November) Fall	Winter (December - February)
Unit Maintenance Rating (Fall Only)			U	
Date of Inspection	03/11/2014 - 03/11/2014		10/24/2014 - 10/24/2014	
DWR Inspector	Bob Duffey		Bob Duffey	
Accompanied By	Bryan Reniff Sutter Maintenance Yard		Bryan Reniff Sutter Maintenance Yard

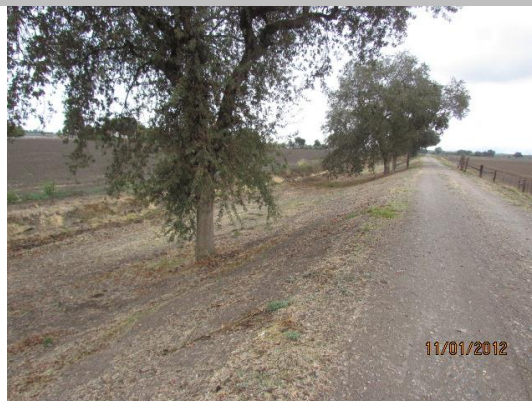
Photo 1 of 1 : FA\_2014\_MA0017\_339\_2\_20141013\_00002.jpg

LM Start	4.18	Rating **	U	Issue No.	2
LM End	7.30	Issue Type +	Ma	Location *	WS
Category	Earthen Levee			GPS Latitude/Longitude	
				Start	End
Item	Trim / Thin Trees			39.142155 °	39.118735 °
				-122.902343 °	-122.884892 °
DWR ID	DWR_MA0017_01_s_2012_2				
Action/Comments					
Thin trees to allow visibility of the ground and room to flood fight.

View of the trees on the waterside slope of the Levee.

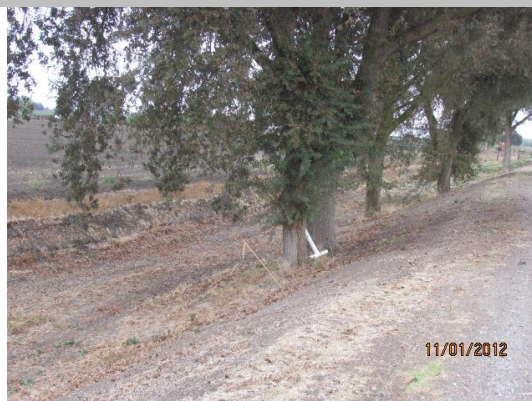
Photo 1 of 1 : FA\_2014\_MA0017\_339\_1\_20141013\_00001.jpg

LM Start	4.18	Rating **	U	Issue No.	1
LM End	7.31	Issue Type +	Ma	Location *	WS
Category	Earthen Levee			GPS Latitude/Longitude	
				Start	End
Item	Vegetation			39.142155 °	39.118675 °
				-122.902343 °	-122.884772 °
DWR ID	DWR_MA0017_01_s_2012_1				
Action/Comments					
Remove the wild growth other than native grasses from the levee slopes.

View of the six-foot crown levee &amp; heavy vegetation on waterside slope.

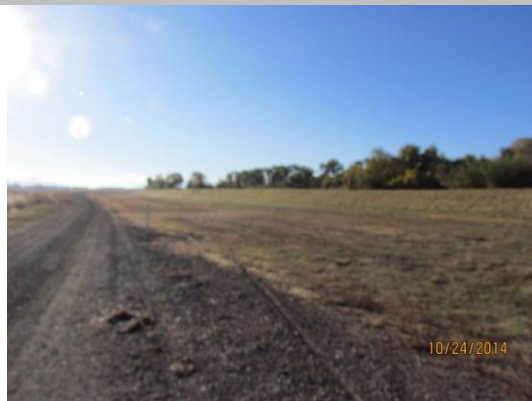
Photo 1 of 1 : FA\_2014\_MA0017\_339\_260\_20141118\_00065.jpg

LM Start	4.60	Rating **	A	Issue No.	260
LM End	4.60	Issue Type +	Ma	Location *	LS
Category	Earthen Levee			GPS Latitude/Longitude	
				Start	End
Item	Vegetation			39.136552 °	39.136552 °
				-122.900863 °	-122.900863 °
DWR ID	DWR_MA0017_01_f_2014_260				
Action/Comments					
Control annual grass and weeds on the levee slopes and easements.

View of mowed vegetation on the landside slope.

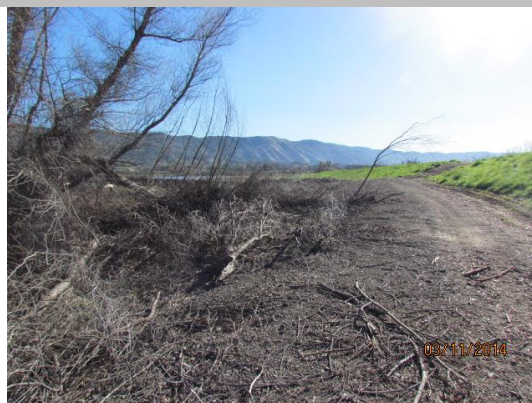
Photo 1 of 1 : FA\_2014\_MA0017\_339\_18\_20141013\_00004.jpg

LM Start	5.39	Rating **	M	Issue No.	18
LM End	5.39	Issue Type +	En	Location *	LS
Category	Earthen Levee			GPS Latitude/Longitude	
				Start	End
Item	Encroachments			39.127544 °	39.127544 °
				-122.893763 °	-122.893763 °
DWR ID	DWR_MA0017_01_s_2014_18				
Action/Comments					
Tree or limb

View of the downed tree along the landside toe.

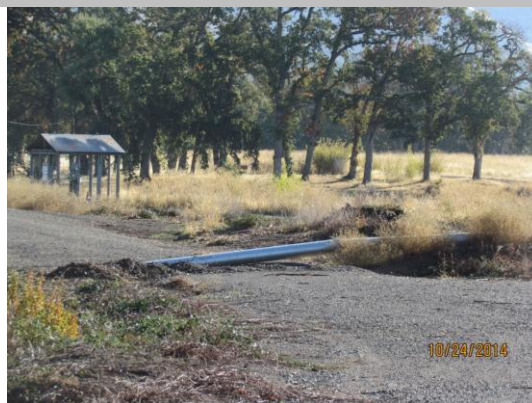
Photo 1 of 1 : FA\_2014\_MA0017\_339\_5\_20141118\_00066.jpg

LM Start	6.08	Rating **	M	Issue No.	5
LM End	6.08	Issue Type +	En	Location *	LS
Category	Earthen Levee			GPS Latitude/Longitude	
				Start	End
Item	Encroachments			39.126003 °	39.126003 °
				-122.883353 °	-122.883353 °
DWR ID	DWR_MA0017_01_s_2013_5				
Action/Comments					
Pipe Inspector Comments: View of the pipe encroachment crossing the crown.

View of the pipe encroachment crossing levee.

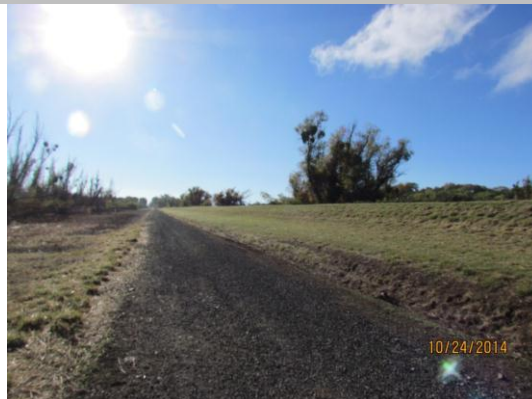
Photo 1 of 1 : FA\_2014\_MA0017\_339\_261\_20141118\_00067.jpg

LM Start	6.74	Rating **	A	Issue No.	261
LM End	6.74	Issue Type +	Ma	Location *	LS
Category	Earthen Levee			GPS Latitude/Longitude	
				Start	End
Item	Vegetation			39.124650 °	39.124650 °
				-122.891787 °	-122.891787 °
DWR ID	DWR_MA0017_01_f_2014_261				
Action/Comments					
Control annual grass and weeds on the levee slopes and easements.

View of the mowed vegetation on the landside slope.
